AN ILLUSTRATED TRANSLATION OF THE NRC'S REPORT ON "FAILURE OF SAFETY/RELIEF VALVE TEE-QUENCHER SUPPORT BOLTS" AT THE HATCH NUCLEAR PLANT

The Nuclear Regulatory Commission's (NRC's) Morning Report No. 2-2005-0005 dated March 14, 2005, related the following information received from the owner of the Edwin I. Hatch nuclear plant in Georgia:

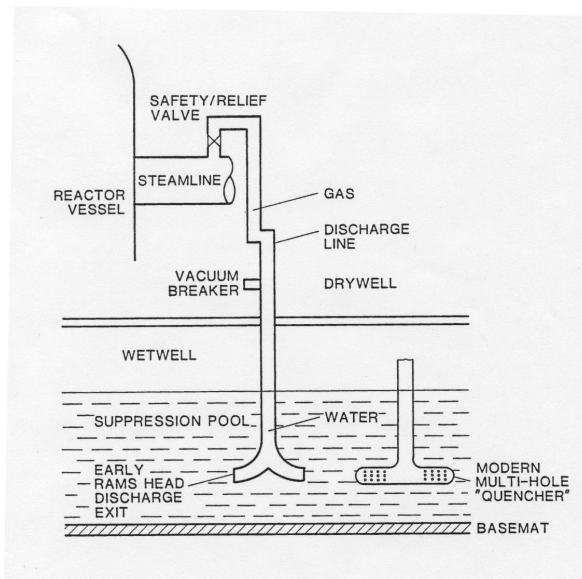
could over-pressure the pipes and cause them to break if it wasn't for safety/relief valves that open to let the steam flow into the suppression pool as shown in the graphic.

The original design discharged the steam beneath the surface of the suppression pool water via what were called rams head nozzles. Experience revealed problems with this arrangement, particularly when only one or two of the eleven safety/relief valves opened. Steam blowing unequally into the suppression pool water caused "sloshing." The wave action from two million gallons of water could damage the suppression pool's walls. To prevent such damage, the rams head nozzles were replaced with tee-quenchers. Like a garden sprinkler hose having many spray holes, the tee-quenchers disperse the steam flow into the water so as to minimize wave action.

At Hatch, each of the eleven tee-quenchers on Unit 2 is bolted to support plates mounted on the basemat of the suppression pool using four bolts. Workers at Hatch discovered one broken bolt on five of the eleven tee-quenchers. The bolts broke due to a combination of stress and corrosion. Impurities in the suppression pool water caused pitting of the metal bolts that forces acting on the bolts turned into cracking that grew until bolts failed. It is also possible that hydrogen present in the suppression pool from an epoxy liner embrittled the metal bolts, allowing their cracks to grow faster and hastening their ultimate failure.

Workers replaced all 44 bolts on the tee-quenchers on Hatch Unit 2 – the five broken bolts plus the 39 other bolts. Similar to showing that a wheel can stay on a car with one lug nut missing, Hatch's owner performed an analysis reportedly showing that three non-broken bolts were sufficient to kept the tee-quenchers in place when the safety/relief valves opened and let steam flow into the suppression pool.

The broken bolts were found during a routine visual inspection. The goal of these inspections is to identify cracked bolts and replace them before they break and reduce safety margins. That didn't happen in this case and the plant's owner and the NRC should seriously evaluate whether the scope and frequency of these inspections needs to be increased to prevent future surprises. Visual inspections may not be sufficient to find degradation like stress corrosion cracking in time to prevent failures.
