## INDIAN POINT: PAST SOME GAS

### EVENT DESCRIPTION

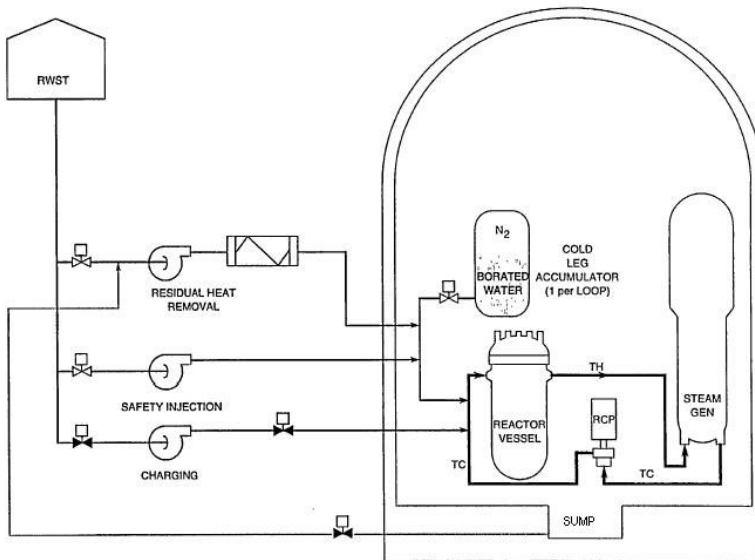
The accumulators are part of the emergency core cooling systems (ECCS) at Indian Point. As shown in the simplified diagram, each accumulator is partially filled with water and covered by nitrogen gas. The accumulators are attached to the cold legs – the piping connecting the discharge of the reactor coolant pumps (RCPs) to the reactor vessel. In event that a pipe breaks and water drains from the reactor vessel, nitrogen “pushes” the accumulator’s water into the cold leg and then into the reactor vessel. The water level and nitrogen pressure in the accumulators is monitored to ensure they remain as high as is needed.

On January 12, 2005, workers identified several valves on the piping between the accumulators and the safety injection pumps (valves not shown in the graphic). The safety injection pumps also form part of the ECCS. Indian Point has three safety injection pumps (represented by a single pump in the drawing) that can transfer water from the Refueling Water Storage Tank (RWST) to the reactor vessel in event of an accident. Work orders were written to examine other locations in the safety injection system, but those examinations were not completed for two weeks.
