FITZPATRICK'S LEAKING DONUT

PRIMARY CONTAINMENT SYSTEM

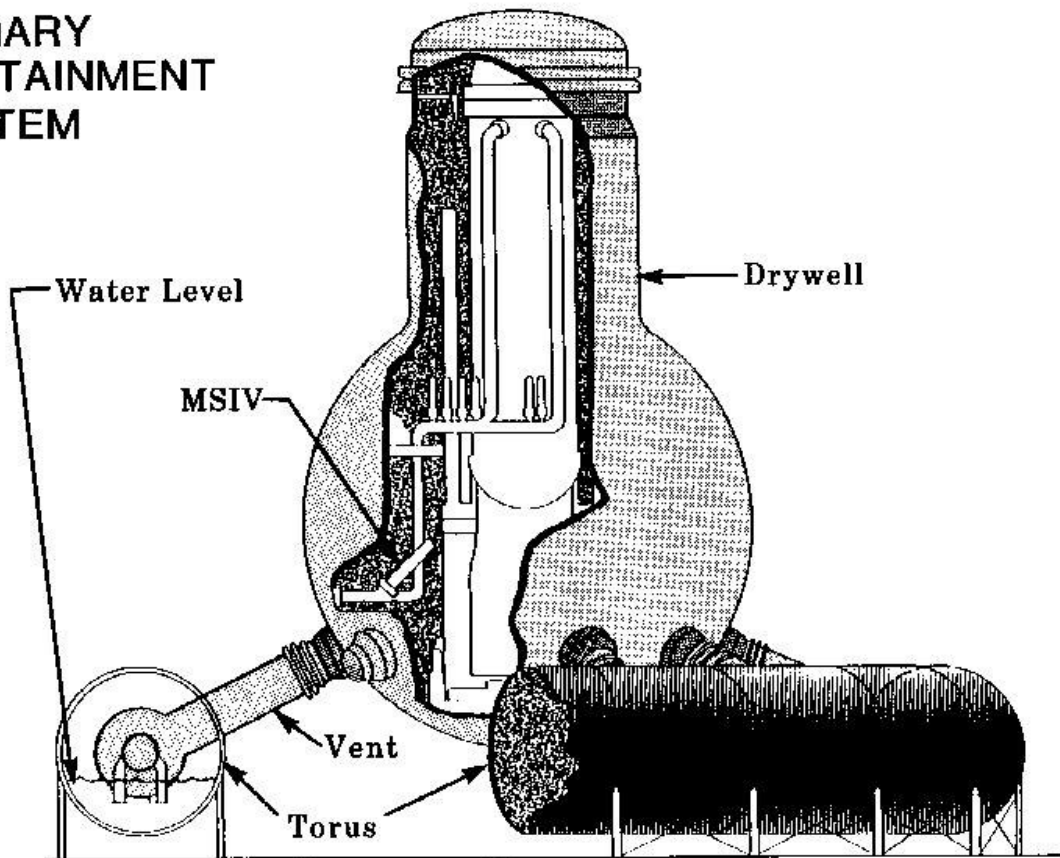
FitzPatrick has a boiling water reactor (BWR) manufactured by the General Electric Company. FitzPatrick is equipped with GE's Mark I primary containment design, sometimes called a lightbulb in a donut because of its shape. The primary containment completely surrounds the reactor vessel and consists of two major parts: the drywell and the torus. The drywell looks like an inverted lightbulb and is made of steel-lined reinforced concrete. The torus looks like a donut and is made of steel covered on the inside by a protective coating. The torus is partially filled with water. The drywell is connected to the torus via eight vent pipes.

Workers found a through-wall crack in the torus about five feet below its waterline and a small puddle on the floor beneath the crack. The leak was discovered during a scheduled inspection of piping connected to the torus. The scope and frequency of the inspection program may be suspect. On July 28, 2003, Entergy asked the NRC for permission to perform integrated tests of containment integrity at FitzPatrick every 15 years instead of every 10 years (see ML0321701280 in NRC's ADAMS). In that request, Entergy described its inspection program for the primary containment as follows:
