# Near Misses at U.S. Nuclear Power Plants in 2015

## *A UCS Nuclear Safety Review*

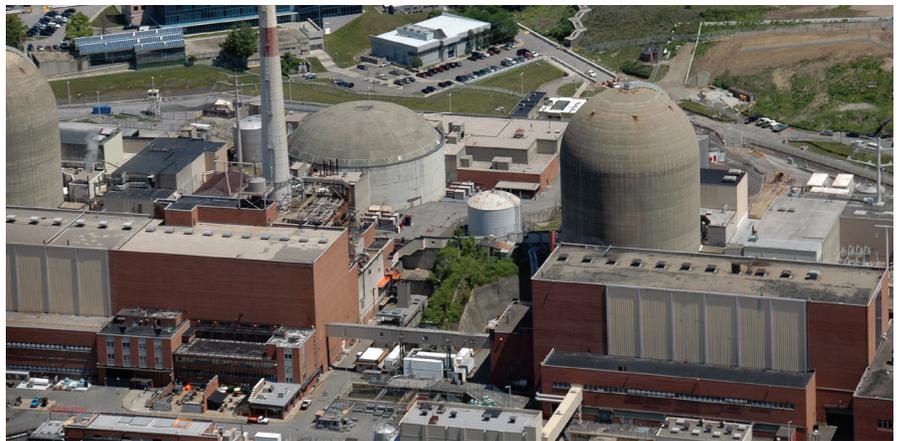
*A transformer explosion at Indian Point Unit 3 on May 9, 2015, caused a fire suppression system component to fail, causing water to flood a room housing vital electrical distribution panels. This component failure is not new; it also malfunctioned during three previous tests, but had not been fixed. However, the NRC did not require Entergy, Indian Point’s owner, to install flooding sensors—a move Entergy itself deemed cost beneficial—because it did not address an aging-related safety issue.*

The NRC sent a special inspection team to Indian Point after an electrical transformer for the Unit 3 reactor exploded on May 9, 2015, resulting in a fire and the automatic shutdown of the reactor. The NRC team was not investigating the cause of the transformer's explosion—it was concerned that

water had flooded an adjacent room housing vital electrical distribution panels. Had the flooding not been discovered and stopped in time, the panels could have been submerged, plunging Unit 3 into a dangerous station blackout, in which all alternating current (ac) electricity is lost. A station blackout led to the meltdown of three nuclear reactor cores at Fukushima Dai-ichi in 2011. Even when a reactor is shut down, ac electricity is needed to cool the reactor core.

The NRC's special inspection team documented that flooding of the room has been a recurring problem. It determined that the flooding was caused by a fire suppression system component that had malfunctioned when it was tested in March 2015, April 2013, and April 2011, but had not been fixed. Its failure once again caused flooding during the May 2015 explosion (NRC 2015e).

The NRC estimated that the component's malfunction allowed about 50 gallons per minute to flow into the room. Drains in the floor were designed to carry away 100 gallons per minute. But the drain pipes were so clogged with debris that only about 25 gallons per minute could exit through them. Workers tested the drains every two years but used a method woefully inadequate for determining whether the drains were clear or blocked (NRC 2015e).

For violating a federal regulation that requires safety problems to be fixed in a timely and effective manner, the NRC issued a Green finding, the least serious in its four color-coded sanction levels (NRC 2015e).

In 2007, Entergy had submitted an application to the NRC for a 20-year extension of the license to operate Indian Point. As part of this process, it evaluated hundreds of proposed modifications to the plant and revisions to procedures that could lessen the chances and/or consequences of accidents. Entergy's evaluation concluded that installing a sensor in the room with the electrical panels to alert the control room operators about flooding would reduce the total risk of core meltdown by about 20 percent and would be cost beneficial. The alarm's \$200,000 cost would be more than offset by the expected benefit of at least \$1.4 million from reducing the risk of core meltdown. Yet the NRC does not require that cost-beneficial modifications be made unless they address a problem related to aging. Because a flood alarm would address a problem that had been in existence since the reactor was built, the NRC has not required Entergy to install this cost-beneficial safety upgrade (Lochbaum 2015d).

***The NRC has not required Entergy to install a flood alarm—a cost-beneficial safety upgrade—at Indian Point.***
