FUTILITY AT THE UTILITY

**How use of the wrong answer key for safety tests
went undetected for 20 years at Fermi Unit 2**

**DAVID LOCHBAUM
DIRECTOR, NUCLEAR SAFETY PROJECT
FEBRUARY 2007**

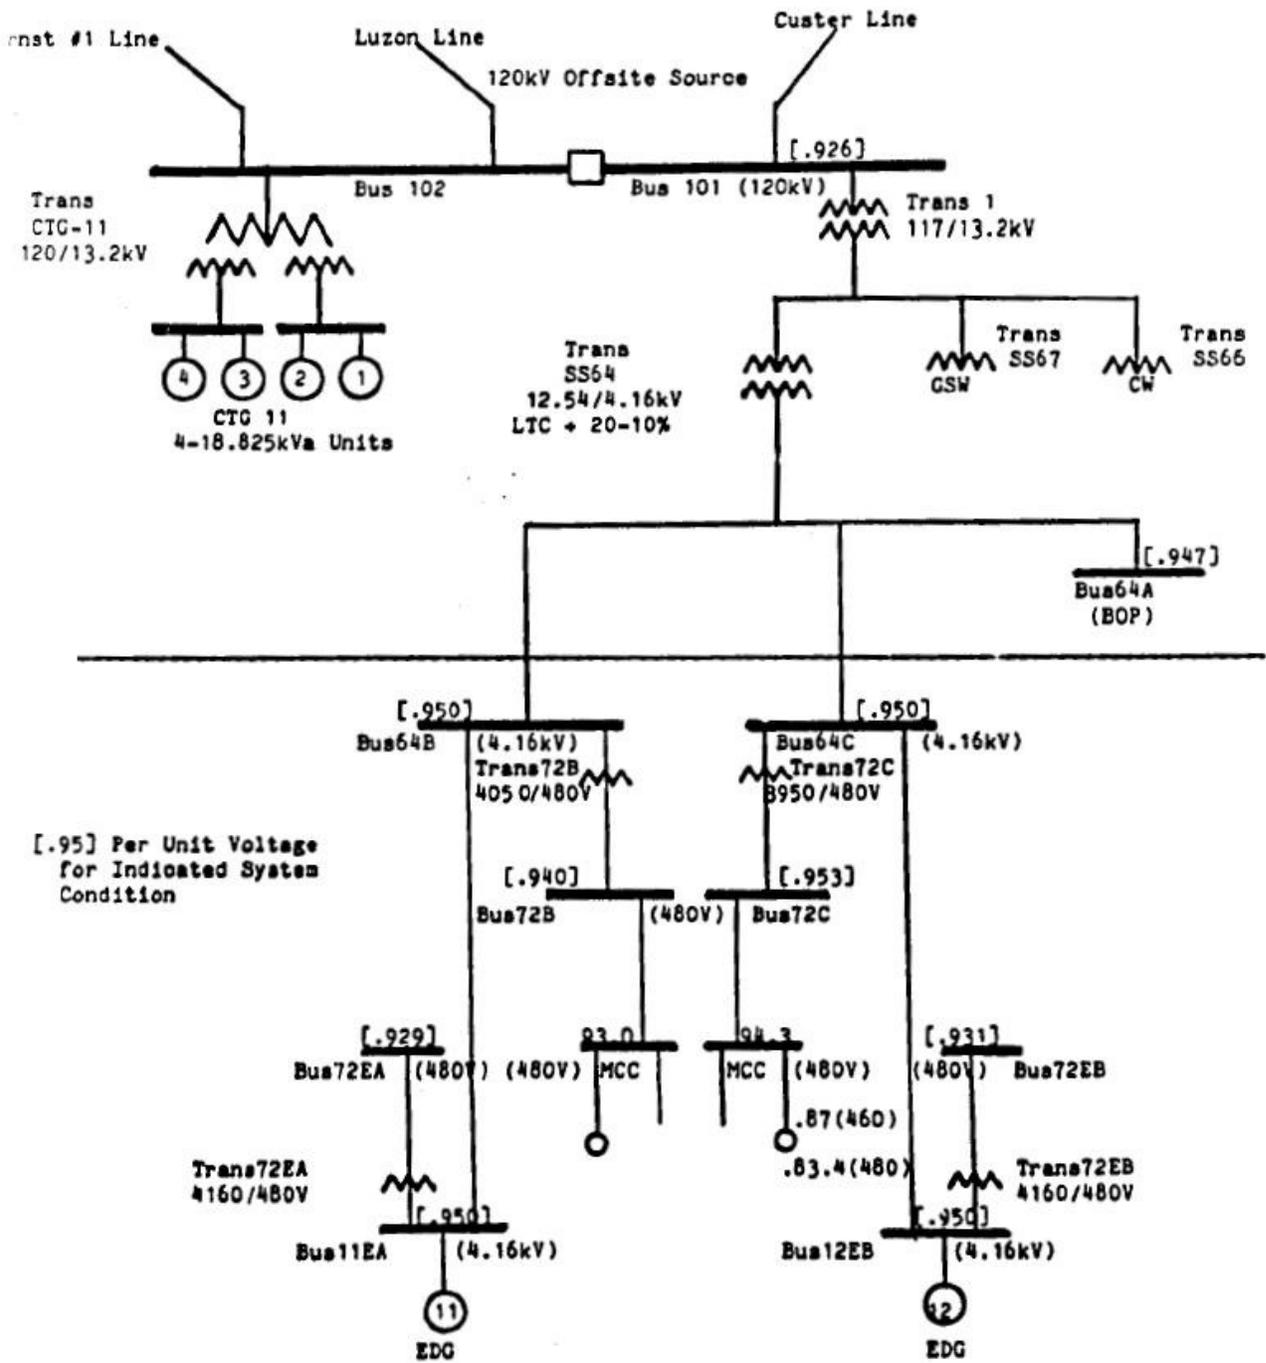
Schematic Diagram-Div I

Figure 1 provides a schematic diagram for one of the two safety-related divisions at Fermi Unit 2. The top portion of the diagram shows the plant's switchyard with the transmission lines connecting the plant to the electrical grid (i.e., the Luzon and Custer lines) along with some of the electrical distribution system for non-essential plant equipment (e.g., Transformer S566 provides electricity to the circulating water (CW) system pumps and equipment). Emergency diesel generators (EDGs) 11 and 12 are shown at the bottom of the diagram providing power to safety-related 4.16 kilovolt electrical buses 11EA and 12EB which in turn supply power to safety-related 480 volt electrical buses 72EA, 72EB, and motor-control centers (MCCs). MCCs are the nuclear plant equivalent to fuse panels in homes: they contain electrical breakers that control power supply to electrical circuits throughout the plant. Non-safety-related 4.16 kilovolt electrical buses 64B and 64C in the middle of the diagram show how the safety-related buses are normally powered from the electrical grid.

Date	Event
January 11, 2001	Specification 3.8.1. ⁸⁴ The NRC reported its inspectors had reviewed Modification 30458 that revised the Bus 64C undervoltage load shed scheme with no findings. ⁸⁵ UCS View: As indicated in Figure 1, Bus 64C is part of the Division 1 electrical distribution system which had the wrong undervoltage trip setpoint in its test procedure. So, there was a “finding” that NRC inspectors failed to make during review.
March 21, 2001	A few hours into the 23-hour endurance run of Emergency Diesel Generator 14, insufficient oil level in the reservoir caused the outboard bearing to overheat and catastrophically fail. ⁸⁶
April 18, 2002	The NRC reported its inspectors had reviewed Revision 47 to surveillance test procedure 24.307.15, “Emergency Diesel Generator 12 – Start and Load Test,” with no findings. ⁸⁷
February 6, 2003	During a test run of Emergency Diesel Generator 11, workers noticed that the exhaust temperature from cylinder 2 was about 100°F below the normal value. The unexpectedly low temperature was attributed to the fuel injector nozzle allowing more fuel oil to flow into the cylinder. The nozzle was sent back to the vendor who found that the torque on the spring that controlled fuel flow rate was set at 20 ft-lbs instead of the required 55 ft-lbs. Workers at Fermi Unit 2 determined that procedure 34.307.001 did not contain sufficient information to ensure the proper torque setting on the injector nozzle spring. ⁸⁸

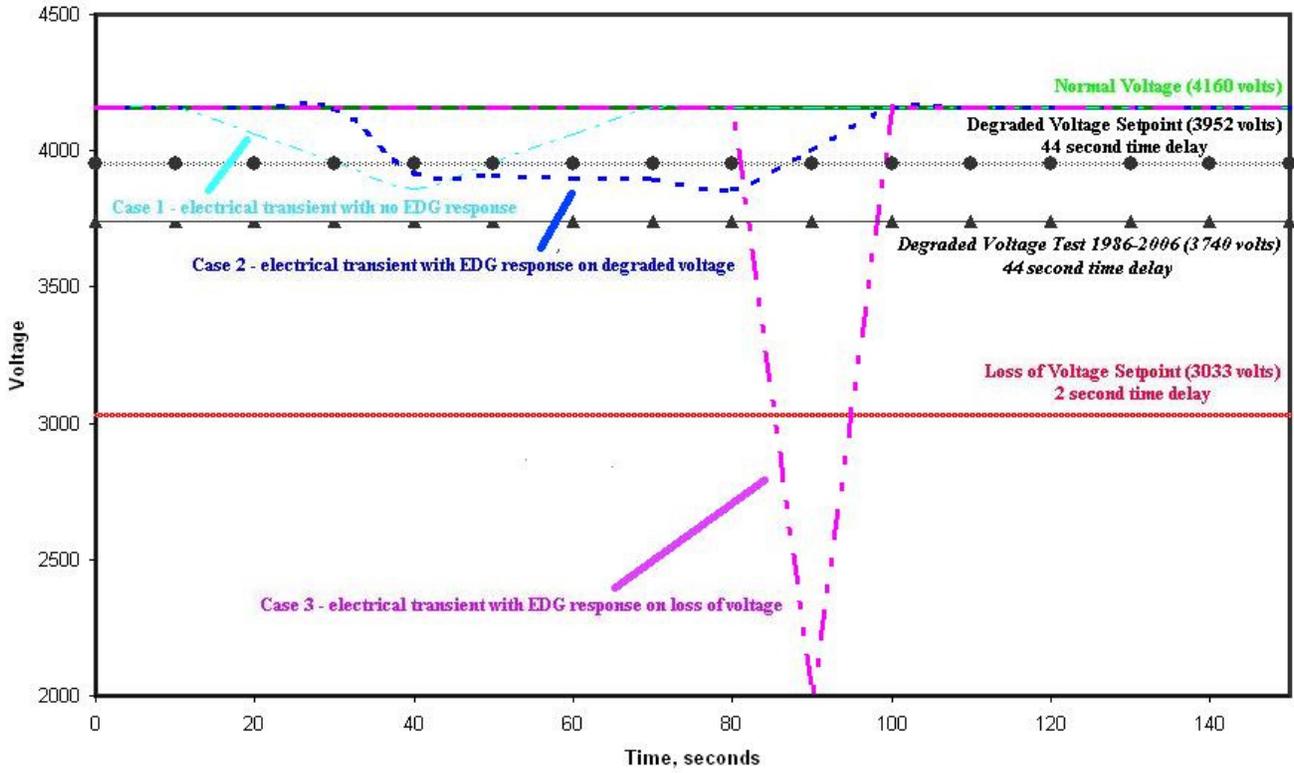
Electrical Bus Voltage Protection

Case 1 – Electrical transient with no EDG response: The electrical bus voltage drops below the degraded voltage setpoint of 3952 volts, starting the 44-second timer. But because the voltage returns to over 3952 volts in less than 44 seconds, no signal to start the emergency diesel generator occurs.

Case 2 – Electrical transient with EDG response on degraded voltage: The electrical bus voltage drops below the degraded voltage setpoint of 3952 volts, starting the 44-second timer. With voltage still below 3952 volts after 44 seconds, the emergency diesel generator is signaled to start. Power from the running emergency diesel generator restores the electrical bus voltage to its normal value.

Case 3 – Electrical transient with EDG response on loss of voltage: The electrical bus voltage drops below the loss of voltage setpoint of 3033 volts, starting the 2-second timer. With voltage still below 3033 volts after 2 seconds, the emergency diesel generator is signaled to start. Power from the running emergency diesel generator restores the electrical bus voltage to its normal value.
