The NRC and Nuclear Power Plant Safety in 2012

TOLERATING THE INTOLERABLE

The NRC and Nuclear Power Plant Safety in 2012: Tolerating the Intolerable

March 2013

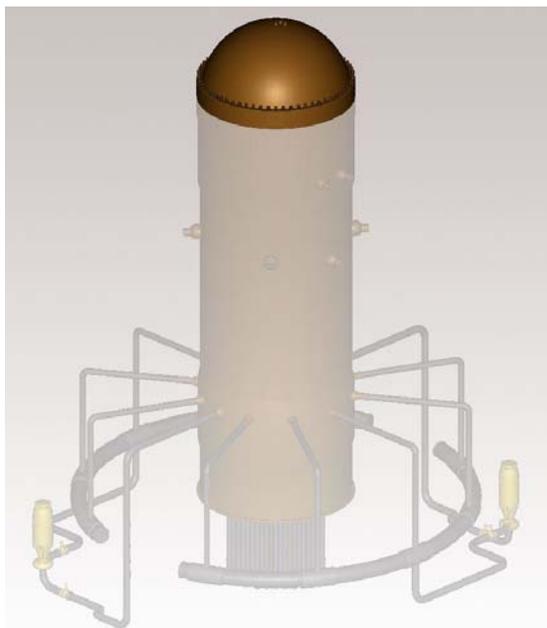
Figure 2: Reactor vessel and its head

The following day, workers turned several of the retaining bolts holding the reactor vessel head on top of the reactor vessel by hand. This should not have been possible. As shown in Figure 2, the reactor vessel head is the dome-shaped part on top of the cylindrical reactor vessel housing the reactor core. The pressure inside the reactor vessel during operation can rise to nearly 1,100 pounds per square inch. The many heavy-duty nuts and bolts are intended to securely fasten the head to the reactor vessel and withstand the internal force.

Workers had unbolted and removed the reactor vessel head earlier in November to enable the damaged fuel assembly to be removed and replaced. When installing the head back onto the reactor vessel, workers used two different methods to verify that each nut was properly tightened on its bolt.

First, workers used a stud tensioner that provided a digital read-out of the force applied to the nut. The installation procedure directed workers to tighten each nut to 13,000 pounds per square inch force. The workers tightened each nut until the digital read-out window displayed 1,300. They believed the value in the window was ten times the force applied. Instead, the window displayed the actual force. Thus, the workers tightened each nut to one-tenth of the proper force.

Because the reactor vessel had not been properly reassembled, the rising pressure inside the reactor vessel during the startup lifted the head enough to squirt water out between the flanges. This hot water increased the temperature in the upper region of the containment and drained down into the basement where instruments detected the increasing leakage rate.

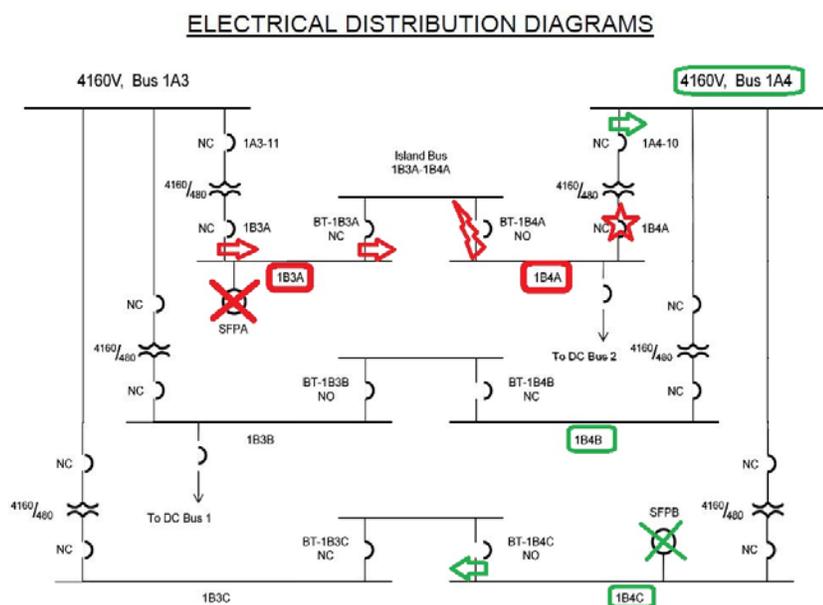
Figure 3: Electrical distribution system at Fort Calhoun

The NRC team discovered that workers noticed an acrid odor in the small room housing electrical breaker 1B4A and 480-volt bus 1B4A three days before the fire. The day before the fire, workers again noticed an acrid odor in the room and entered a report in the plant's corrective action program about it. But even though the plant had instruments onsite to perform thermographic scans of the electrical equipment to identify hot spots that might be sources of the acrid odor, it was not used. The NRC team also determined that workers did not employ low-tech techniques such as opening electrical panels to look for smoke or abnormally high temperatures.

The failed electrical breaker was among 12 breakers replaced in November 2009. The replacement breakers were of a different size and material than the original breakers. These design differences created the potential for the breakers to experience higher temperatures during operation due to increased resistance to electrical current flow. The higher temperature exacerbated the situation by increasing the oxidation rate of internal parts, adding even more resistance to current flow.

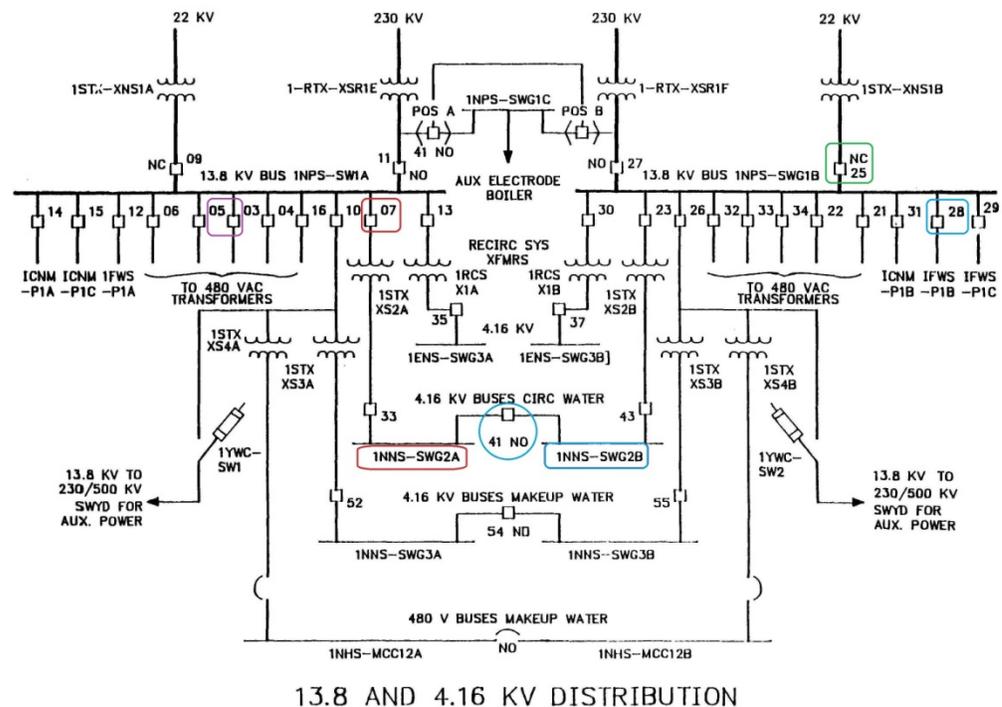
Figure 4 Electrical distribution system at River Bend

One of the electrical cables supplying power from 13,800-volt electrical bus 1NPS-SW1A to 4,160-volt electrical bus 1NNS-SWG2A had failed. Its failure started the fire and caused an electrical breaker (number 07 within the red rectangle in Figure 4) to open. The two circulating water pumps powered from 1NNS-SWG2A stopped running when the bus was de-energized. The other two circulating water pumps, powered from unaffected 4,160-volt electrical bus 1NNS-SWG2B, continued running, but were unable to supply enough flow through the main condenser to prevent the turbine from tripping.

To allow the reactor to be restarted before the damaged cables were repaired or replaced, workers closed a normally open electrical breaker (number 41 within the blue circle in Figure 4) that cross-tied electrical buses 1NNS-SWG2A and 1NNS-SWG2B. This meant that all four circulating

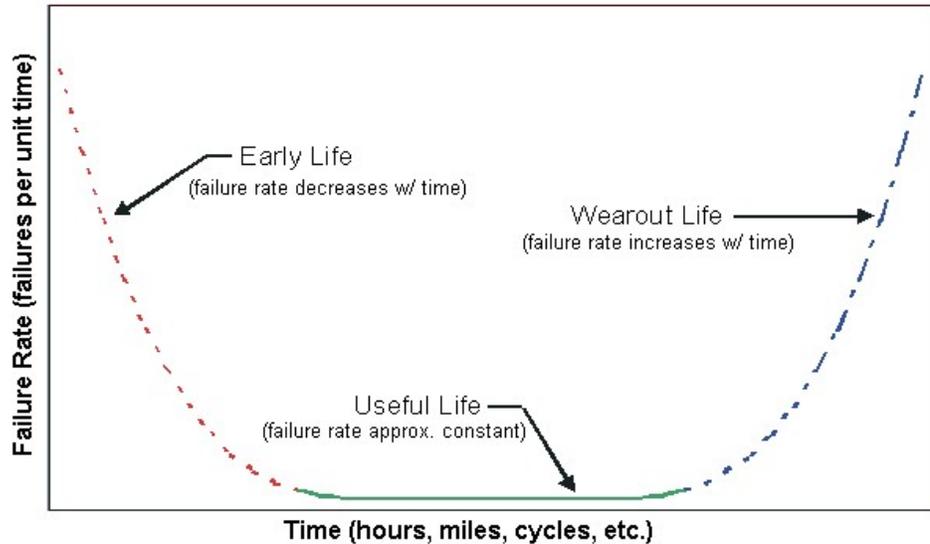
Figure 6: The Bathtub Curve

A failure trend, commonly called the “bathtub curve” due to its shape, explains what happened to San Onofre’s steam generators. The curve shows the chance of failure over a product’s lifetime. The failure rate is initially high during the “break-in” phase due to material defects, assembly errors, and related problems. With time, the failure rate declines until it is lowest during the useful middle of its operational life. The failure rate increases on the right-hand side of the curve during the “wear-out” phase as aging mechanisms such as rusting and embrittlement increase the likelihood of failure. With the original steam generators at San Onofre approaching, if not already in, this

But the replacement steam generators began service not in the middle part of the bathtub curve where failure rates are lowest, but on the left-hand portion of the curve during the break-in phase.

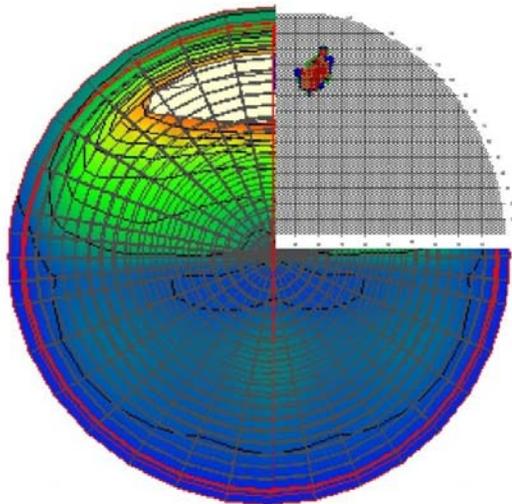
Figure 8: Looking down at steam generator tubes showing problem area on primary inlet (hot) side

The flow patterns inside the steam generators had been extensively analyzed using computer programs modeling the temperature, pressure, and flow conditions. In hindsight, it appears those computer simulations were not realistic.

The NRC must not allow these reactors to restart until the cause of the steam generator degradation has a robust explanation rather than the flimsy, unsubstantiated one offered by the plant's owner to date.

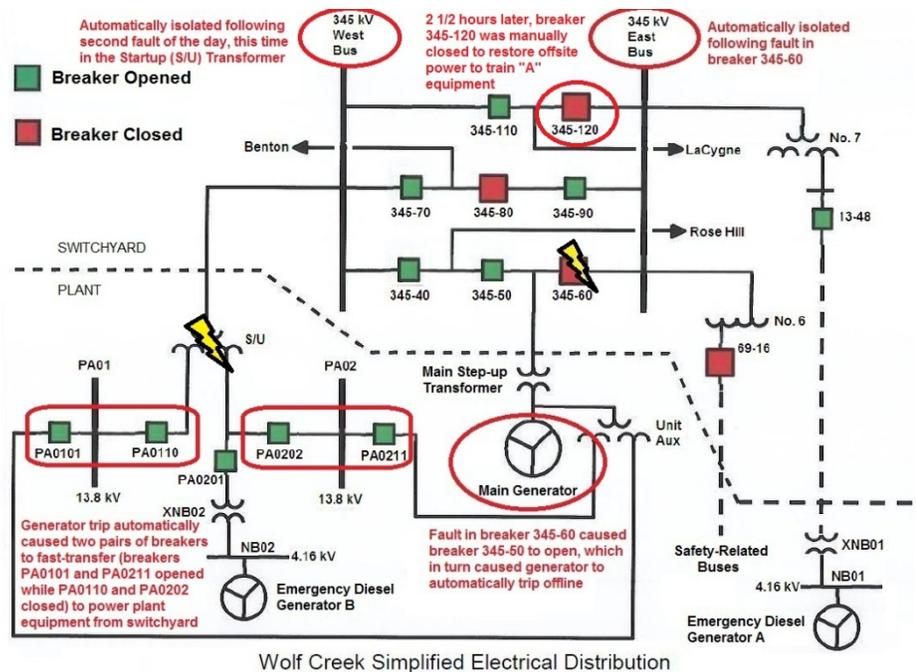
Figure 9: Electrical distribution system at Wolf Creek

Numerous equipment issues complicated the operators' response to the event. The two major complications involved pumps for the fire-protection system and the power-operated relief valve (PORV). Before the event, the normal diesel-driven fire-protection water pump had been taken out of service due to a prior failure. Its backup, a temporary diesel-driven fire-protection water pump, lacked automatic start capability and had been drained of water to prevent it from freezing. Operators experienced difficulty priming the pump to prepare it for service. As a result, the plant lacked a working fire water supply system for about nine hours after the event. The AIT determined that management did not properly implement compensatory measures for the impairment of the fire protection system.

The loss of the normal power supply to in-plant equipment de-energized the instrument air system. Per design, air-operated valves in essential safety systems went to their fail-safe positions. This action stopped water flow through the reactor coolant system's letdown system and boosted flow through the reactor coolant system's charging system to maximum. Maximum makeup to the reactor vessel without any drainage flow pathways increased the pressure inside the vessel. The increasing pressure caused the power-operated relief valve (PORV) to open 23 times to discharge some cooling water from the vessel and protect it from over-pressurization damage. The concern here is that PORVs have a long history of opening and then failing to reclose, providing a pathway to drain cooling water from the reactor vessel. A stuck-open PORV was a major contributor to the March 1979 partial meltdown of the Three Mile Island Unit 2 reactor in Pennsylvania.
