The NRC and Nuclear Power Plant Safety in 2011

The NRC and Nuclear Power Plant Safety in 2011: Living on Borrowed Time

DAVID LOCHBAUM

March 2012

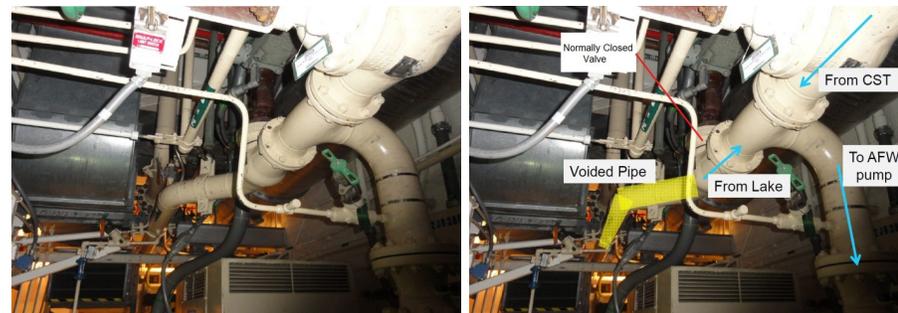
At Byron and Braidwood, this piping supplies water to auxiliary feedwater pumps needed during emergencies to prevent heat from damaging the reactor core. (The two photos are identical, except for the labels on the right-hand photo.) The yellow shading highlights piping drawing water from a nearby lake—the focus of an NRC special inspection.

The longstanding practice at Byron and Braidwood was to keep the pipes from the lake emptied of water, to prevent any untreated lake water from leaking past a closed valve and entering the steam generators, where it could hasten corrosion and rusting. The NRC inspectors questioned whether the volume of air in the empty portion of the piping would impair or disable the auxiliary feedwater pumps if they needed to draw water from the lake.

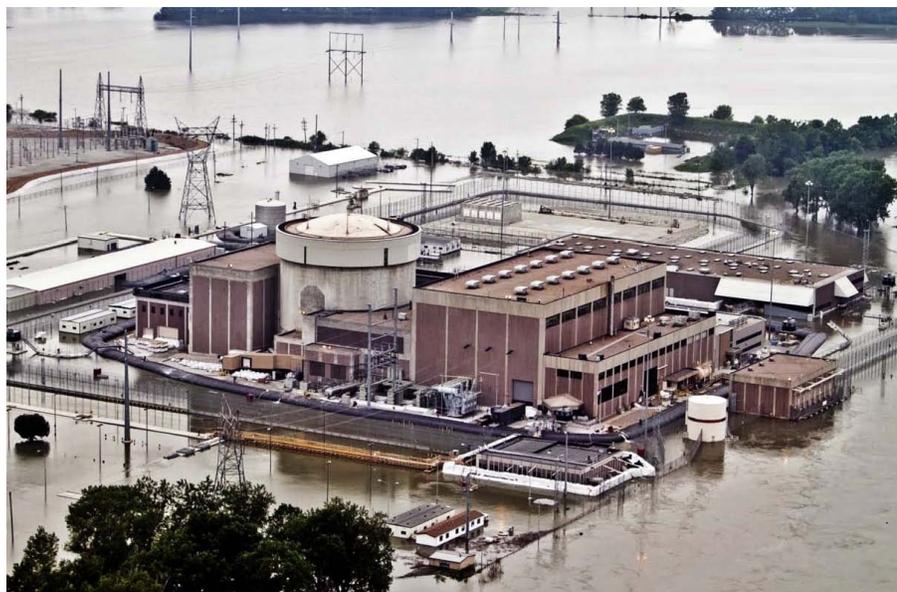
*The Fort Calhoun plant survived severe flooding in June 2011.
Source: Associated Press 06/14/2011*

NRC inspectors discovered that the agency had issued an operating license for Fort Calhoun based on representations by the owner that the facility could withstand flooding up to 1,014 feet above mean sea level. However, NRC inspectors found that flooding above 1,008 feet could disable vital equipment in several structures.
