## DAVIS-BESSE'S LEAKING DECAY HEAT REMOVAL LINE

The Nuclear Regulatory Commission's daily event report No. 43880 dated January 4, 2008, covered the notification to the agency by FirstEnergy that workers at the Davis-Besse nuclear plant in Ohio had discovered reactor cooling water leaking from a weld in the common piping section of the decay heat removal system. Davis-Besse was shut down late last month for a refueling outage. When Davis-Besse is operating, the heat produced by the reactor core is

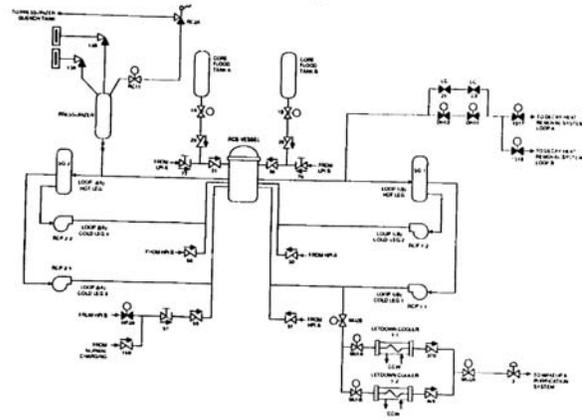
Workers at Davis-Besse were applying an overlay to welds holding the pipe segments together in the decay heat removal system’s single line inside containment. An emerging problem in the nuclear industry involves degradation of welds holding pipes of differing materials together. The overlay process is intended to protect against that degradation. During that process, a welder noticed water leaking from a crack in the weld. It was a small leak, characterized as “seepage,” but a leak nonetheless.

Whether this known weld crack is the only significant one at Davis-Besse is uncertain at this time. If so, its repair is relatively simple and the risk implications of past operation with the crack are minimal. If not, the repairs and risk implications grow larger. In October 1999, FirstEnergy released a report on a probabilistic risk assessment it had conducted for Davis-Besse. Among the outcomes from this effort was a ranking of the risk consequences from key safety equipment being out of service. While this probabilistic safety assessment analyzed the risk impacts from safety equipment being out of service with the reactor operating at full power, it still provides useful insights into the relative importance of key safety systems during outage conditions. According to FirstEnergy’s analysis, a single decay heat removal pump being out of service increased the risk of core damage by a factor of 5 to 10. That risk impact is greater than the loss of the pressurizer power-operated relief valve (PORV, made infamous for its role in the meltdown at Three Mile Island), the loss of the high pressure injection pump (one of the safety components fixed during Davis-Besse’s prolonged 2002-2004 outage), or the loss of an emergency diesel generator.

Because the cracked weld is on the common suction line to both decay heat removal pumps, it involves at least the potential for both decay heat removal pumps being lost. Consequently, FirstEnergy declared both sets of decay heat removal inoperable pending investigation of the extent of the problem and implementation of repairs.
