VERMONT YANKEE EVENT

Nuclear Regulatory Commission (NRC) Daily Event Report No. 41868 dated July 25, 2005, provided preliminary information about an event occurring that day at the Vermont Yankee nuclear plant. This issue brief translates the nukespeak in that report into plain English:

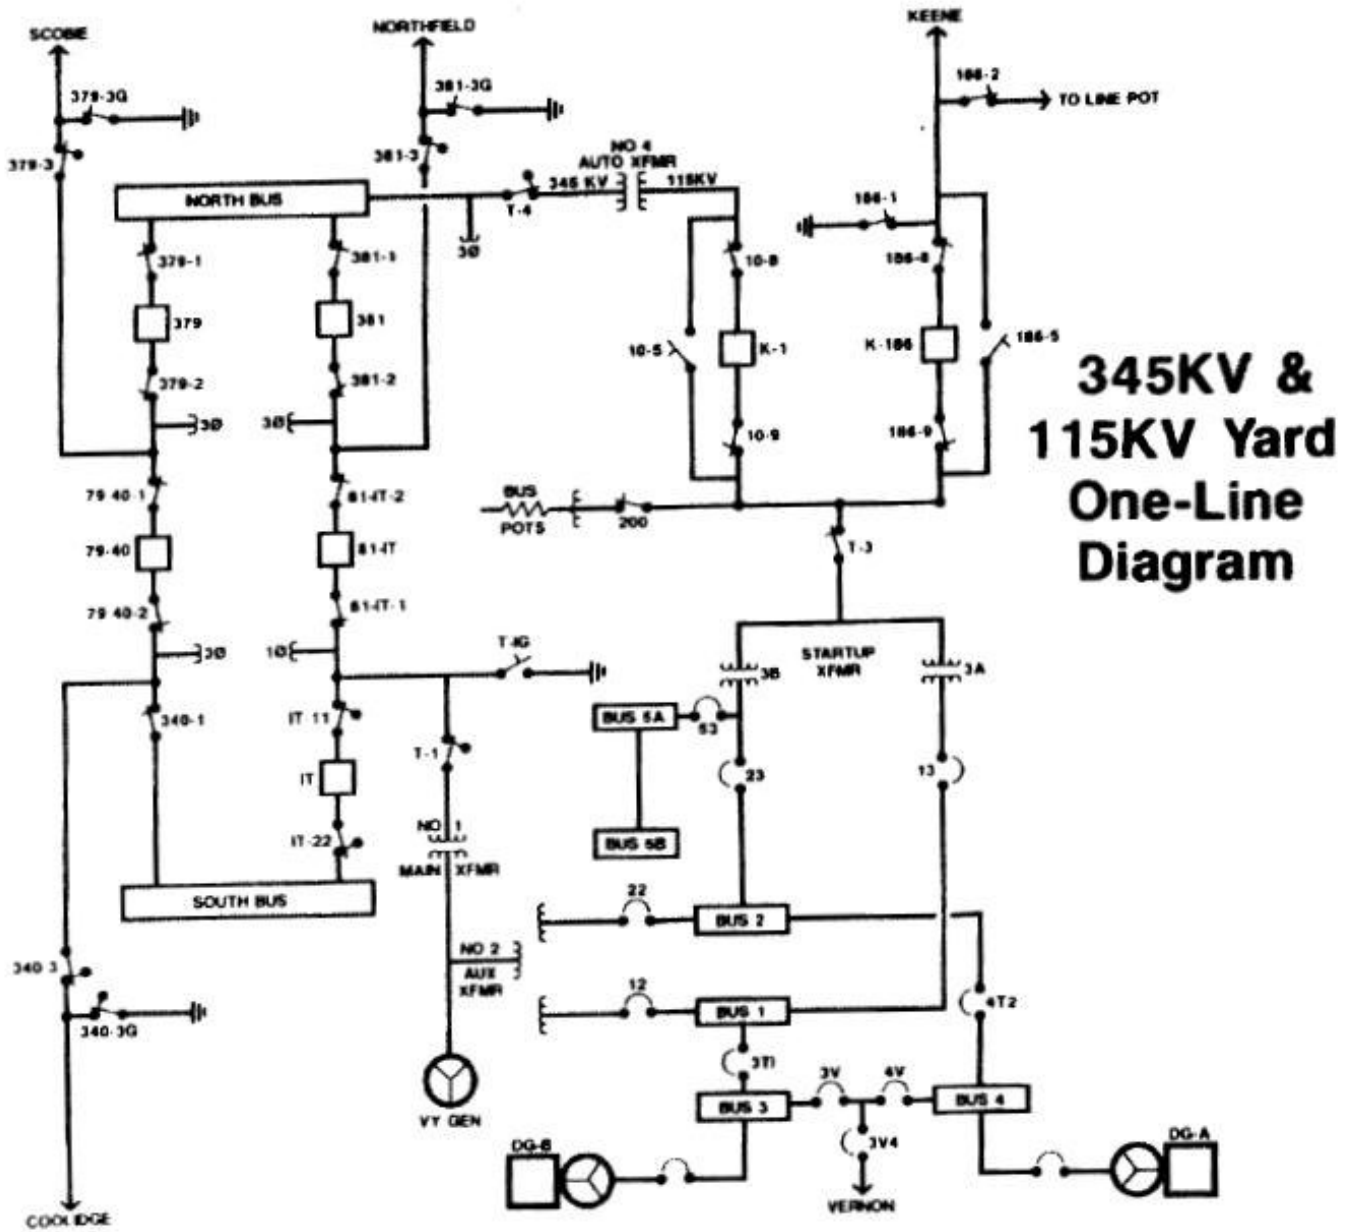
FIGURE 1

NOTE: Figure 1 shows the Vermont Yankee switchyard. Figures 2 and 3 illustrate reactors like that at Vermont Yankee.

Report	Translation
<i>At 1525 the plant experienced a load reject generator trip due to a catastrophic failure in the 345 kV switchyard. A reactor scram occurred as a result.</i>	At 3:25pm, a serious electrical problem at Vermont Yankee caused the main generator to automatically trip offline which in turn caused the nuclear reactor to automatically shut down. The 345 kV switchyard is shown in the upper left of Figure 1. The main generator is the circle around the “Y” in the lower center with the label “VY GEN.”
<i>The degraded AC power system prevented a fast transfer from occurring.</i>	The trip of the main generator meant that less electricity flowed through the No. 2 Auxiliary Transformer and Breaker 12 to Bus 1 and Breaker 22 to Bus 2. This power supply reduction prevented the automatic transfer of Bus 1 and Bus 2 from the No. 2 Auxiliary Transformer to the Startup Transformer. By design, a fast transfer would have quickly closed Breaker 12 for Bus 1 and immediately opened Breaker 13 while Breaker 22 would have closed fro Bus 2 while Breaker 23 opened.

<i>Degraded bus voltage caused the emergency diesel generators (EDGs) to start.</i>	The power supply reduction to Bus 1, which in turn meant less power though Breaker 3T1 to Bus 3, and to Bus 2 (and via Breaker 4T2 to Bus 4) caused the two emergency diesel generators – shown as the circles around the reclining Y’s – to automatically start.
<i>A residual bus transfer restored power to the 4 kV busses.</i>	Bus 1 and Bus 2 were realigned from the No. 2 Auxiliary Transformer to the Startup Transformer. The Startup Transformer was being powered from the 115 kV switchyard (upper right) so power was restored to Busses 1, 2, 3, and 4.
<i>The [main steam isolation valves] MSIVs closed on a low-low reactor water level of 82.5 inches. [Reactor Core Isolation Cooling] and [High Pressure Coolant Injection] (HPCI) also started on the low-low reactor vessel water level.</i>	As shown in Figure 2, the normal water level in the reactor vessel is about 14 feet above the top of the reactor core. The collapsing of bubbles when the reactor automatically shut down – similar to the effect of lifting a boiling pan of water off a stove – along with the increased pressure resulting from the closure of the turbine inlet valves drove the water level down about seven feet to the level where the main steam isolation valves (MSIVs) automatically closed and the Reactor Core Isolation Cooling (RCIC) and High Pressure Coolant Injection

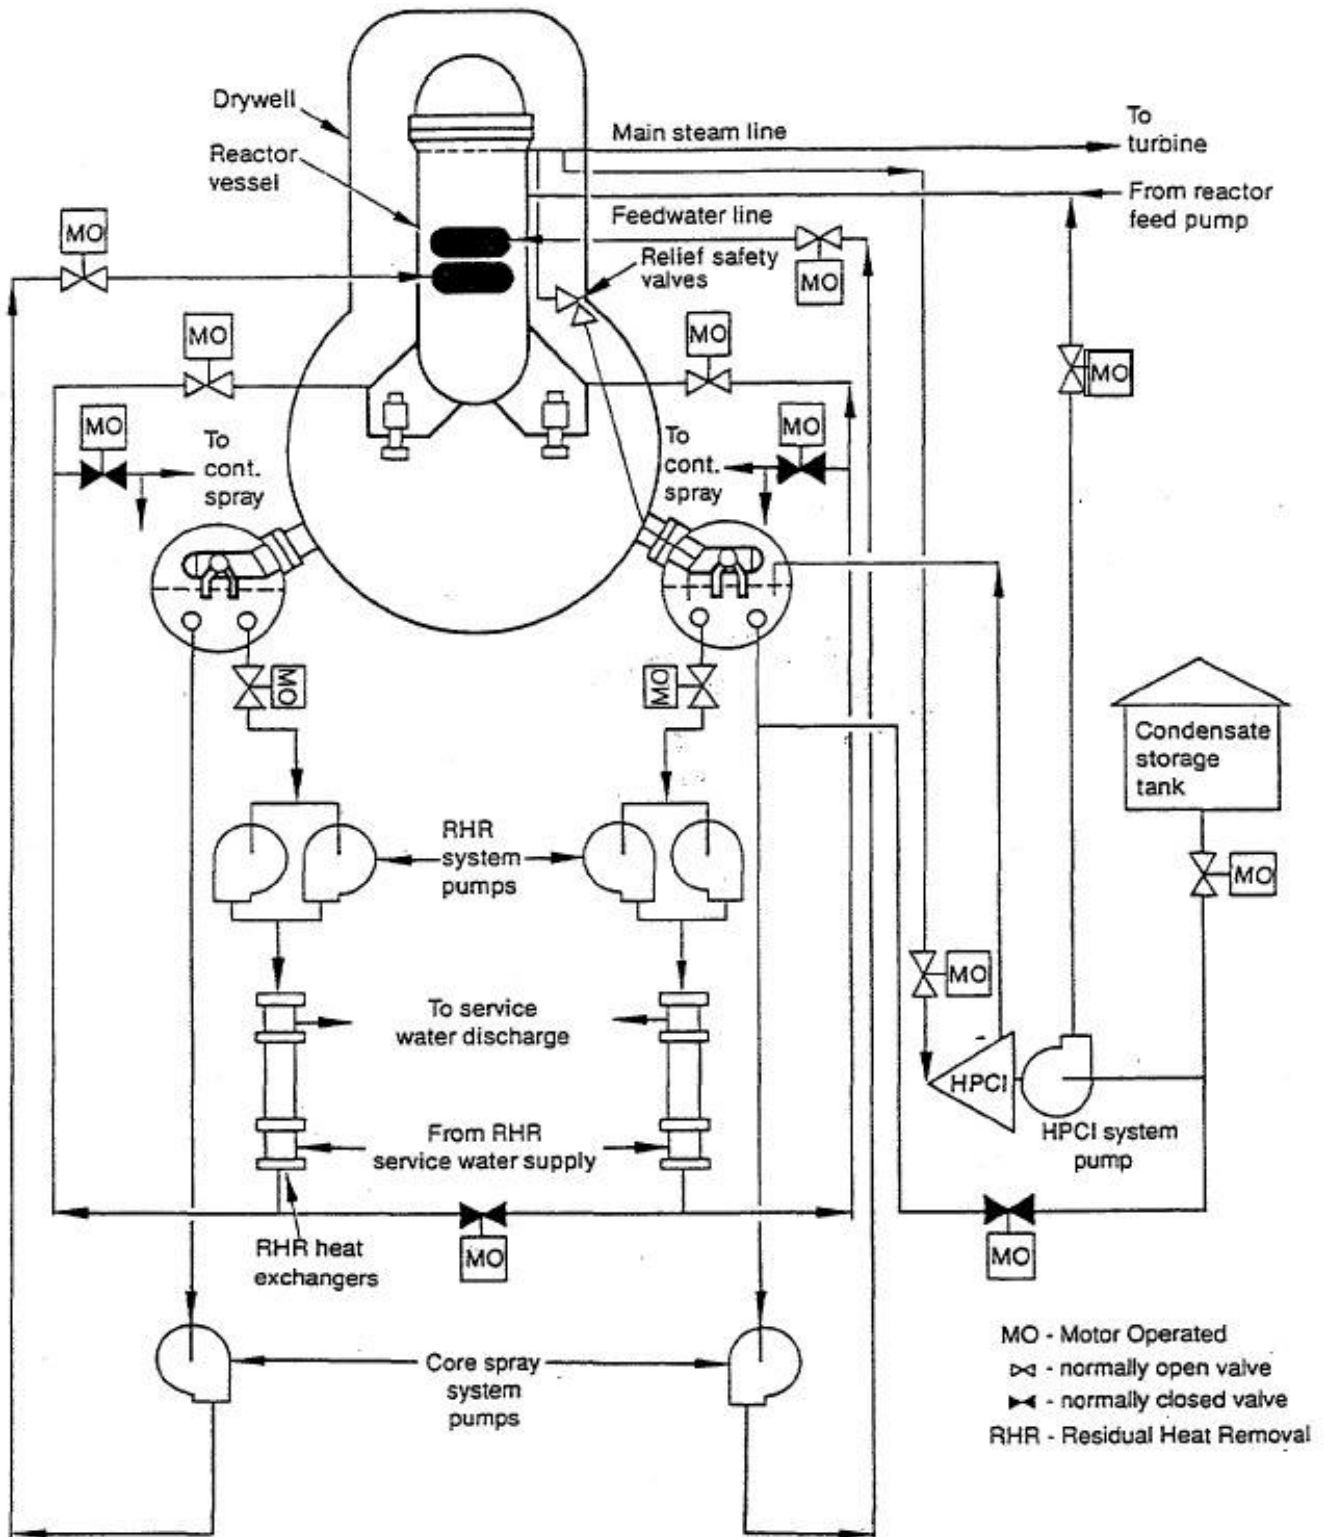
FIGURE 3

Report	Translation
	(HPCI) systems automatically started. The MSIVs are not shown in Figure 3, but are located in the main steam line in the upper right between the reactor vessel and the main turbine. They automatically close on low-low water level inside the reactor vessel to prevent further loss of cooling water inventory. The HPCI system (shown on the right side of Figure 3) uses a steam-driven pump to provide makeup water from the Condensate Storage Tank to the reactor vessel. The RCIC system (not shown on Figure 3 but very similar) also employs a steam-driven pump to transfer water from the Condensate Storage Tank to the reactor vessel.
<i>The [Safety Relief Valves] were cycled twice for pressure control.</i>	The safety relief valves (shown as the bent bowtie to the lower right of the reactor vessel in Figure 3) allow steam from the main steam lines to flow into the water-filled torus (shown as the two circles on either side of the inverted lightbulb that is the drywell containment structure). The closure of the MSIVs bottled up the steam produced by decay heat from the shut down reactor core. The safety relief valves opened and closed twice to give that steam someplace to go and reduce pressure inside the reactor vessel.

<i>EOP-3 was entered due to elevated torus water temperature and both loops of [Residual Heat Removal] (RHR) are in torus cooling.</i>	The steam flowing through the safety relief valves into the water-filled torus warmed up that water. To cool the torus water, both RHR loops (each loop consisting of an RHR pump and an RHR heat exchanger) took water from the torus, cooled it, and returned it to the torus. Operators at Vermont Yankee followed Emergency Operating Procedure No. 3 to guide their actions.
<i>Water level has restored and is being maintained by feedwater. The MSIVs have been reopened and the scram reset. EDGs were secured.</i>	The HPCI and RCIC systems added sufficient water to the reactor vessel to raise the level back to the normal level. The MSIVs were opened and the normal feedwater system used to keep the reactor vessel water level at the normal level. The emergency diesel generators were manually turned off.
