AN ILLUSTRATED TRANSLATION OF THE NRC'S REPORT ON "FAILURE OF SAFETY/RELIEF VALVE TEE-QUENCHER SUPPORT BOLTS" AT THE HATCH NUCLEAR PLANT

The Nuclear Regulatory Commission's (NRC's) Morning Report No. 2-2005-0005 dated March 14, 2005, related the following information received from the owner of the Edwin I. Hatch nuclear plant in Georgia:

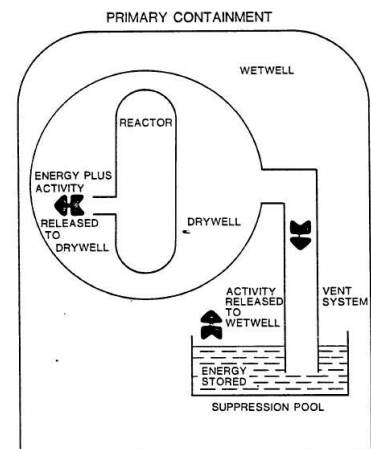
The primary containment is made of reinforced concrete to provide strength against the energy released from the reactor during an accident. That energy can be high enough to burst the thick, reinforced concrete walls if it wasn't for energy absorption by nearly two million gallons of water sitting in the suppression pool (also called the torus at Hatch due to its doughnut shape). During an accident, the energy is channeled

through vent pipes and discharged below the surface of the water in the suppression pool. The water absorbs much of that energy, enabling the reinforced concrete walls to withstand the remaining energy.
