# Near Misses at U.S. Nuclear Power Plants in 2015

## *A UCS Nuclear Safety Review*

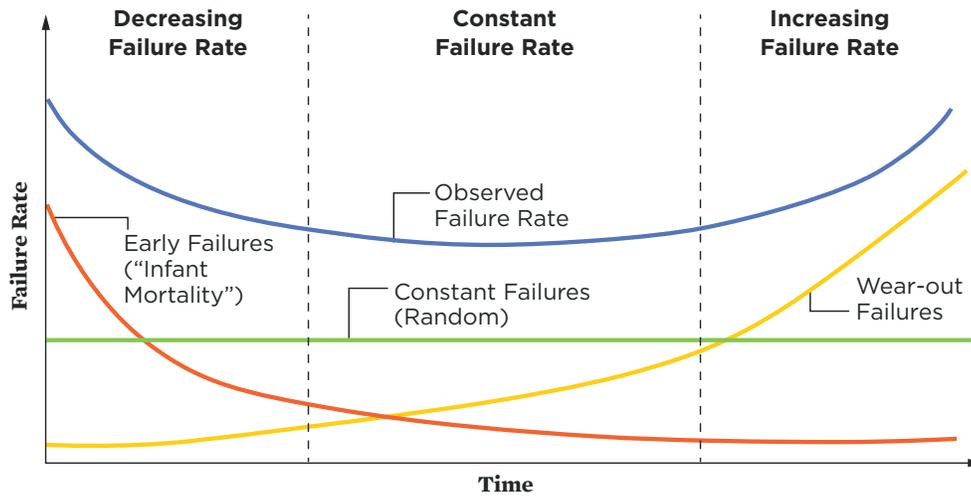
## The Bathtub Curve

This incident demonstrates the bathtub curve (see the figure, p. 4) in action (Lochbaum 2015b). The NRC was properly concerned that the original torus coating at Duane Arnold might be approaching, if not already be within, the right-hand portion of the curve where age increases the chance of failure. So, the NRC compelled the owner to replace the original coating as a condition of getting a 20-year extension to the reactor operating license. But the new coating reset the clock and flipped things back to the left-hand portion of the curve, where the chance of failure is initially elevated due to material defects, improper installation, and other “infant mortality” factors. Thus, an effort to

The bathtub curve illustrating the chance of failure (vertical axis) over a product's lifetime (horizontal axis).

The bathtub curve claimed another victim (Lochbaum 2015b). Workers replaced parts within the valves because the original parts were susceptible to an aging mechanism that hastened their entry into the wear-out zone. Their efforts to avoid component failure were defeated when the replacement parts were even more susceptible to another problem. Within hours, the replacement parts failed, preventing the rebuilt valves from getting out of the break-in phase and heading towards the wear-out zone.
