The NRC and Nuclear Power Plant Safety in 2011

The NRC and Nuclear Power Plant Safety in 2011: Living on Borrowed Time

DAVID LOCHBAUM

March 2012

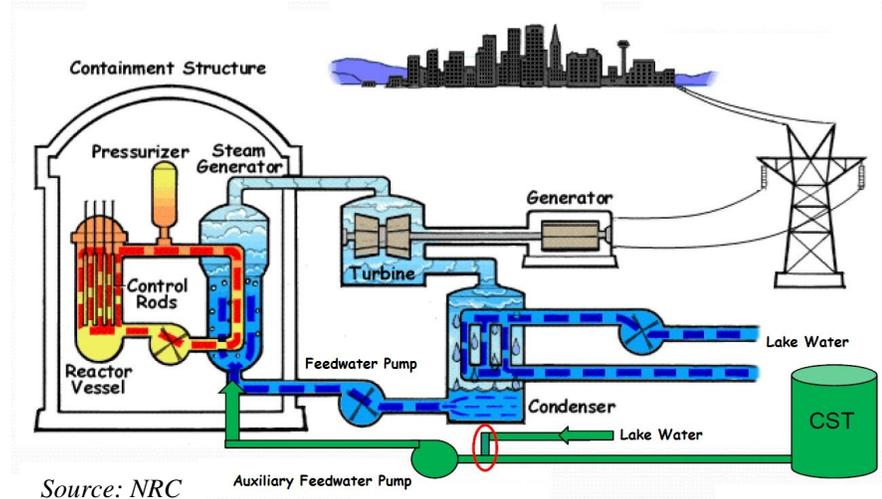
Figure 2. Outline of a Pressurized Water Reactor Such as Byron and Braidwood

On January 31, 2011, NRC inspectors at Byron questioned the longstanding practice of maintaining portions of piping for the essential service water supply to auxiliary feedwater pumps empty of water. The NRC raised the same issue at the Braidwood plant because it had a similar design and operating procedures (Figure 2).

At Byron and Braidwood, the auxiliary feedwater pumps are normally in standby mode, ready to provide makeup water to the steam generators when the feedwater pumps cannot do so. Makeup water absorbs heat from water circulating between the reactor vessel and steam generators. This vital process removes heat produced by the reactor core, preventing damage to the core caused by overheating.

The auxiliary feedwater pumps usually transfer relatively clean, treated water from the condensate storage tank (CST) to the steam generators. The auxiliary feedwater pumps can also transfer untreated water from a nearby lake when the CST empties or cannot be used.

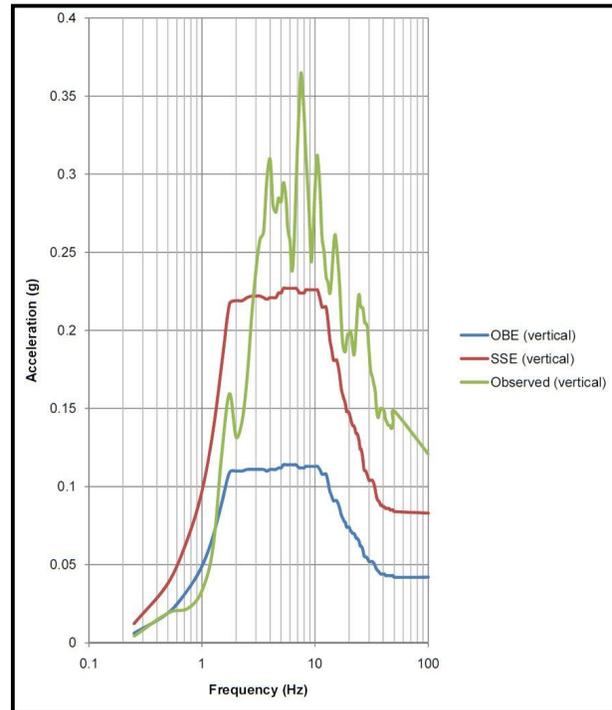
Figure 4. Ground Motion from an Earthquake at the North Anna Plant

The NRC sent an AIT to the site following an earthquake that caused ground motion greater than the plant was designed to withstand (Figure 4).

The blue line shows the ground motion (in g's), considered in the plant's design, from an operational-basis earthquake (OBE)—one severe enough to prevent the plant from operating. The red line shows ground motion from a safe shutdown earthquake (SSE)—one severe enough to potentially damage the main turbine/generator, but not emergency equipment needed to cool the reactor core. The green line is the actual ground motion measured at the plant during the August 2011 earthquake. The horizontal axis shows how fast the ground is shaking.
