## DAVIS-BESSE'S LEAKING DECAY HEAT REMOVAL LINE

The Nuclear Regulatory Commission's daily event report No. 43880 dated January 4, 2008, covered the notification to the agency by FirstEnergy that workers at the Davis-Besse nuclear plant in Ohio had discovered reactor cooling water leaking from a weld in the common piping section of the decay heat removal system. Davis-Besse was shut down late last month for a refueling outage. When Davis-Besse is operating, the heat produced by the reactor core is

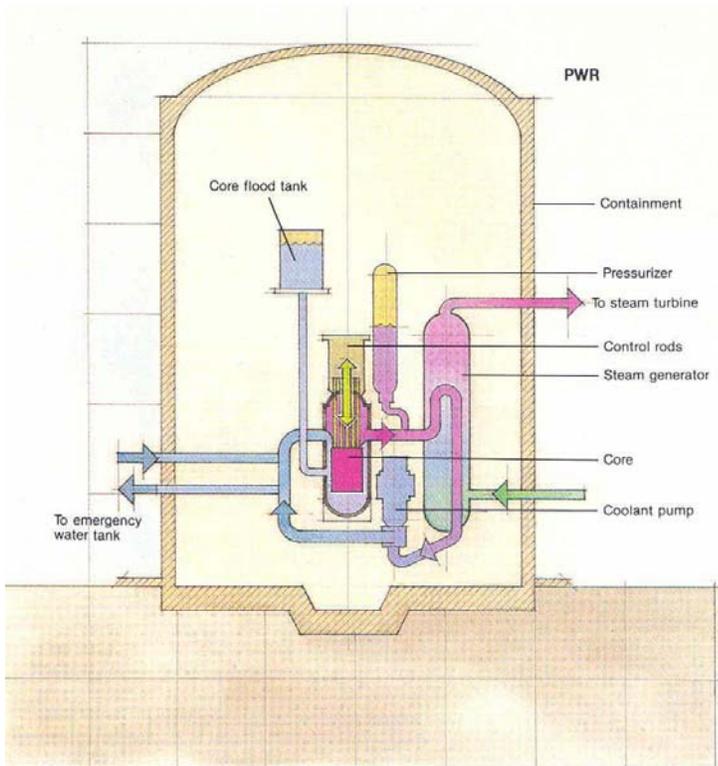
removed by circulating hot, pressurized water through two steam generators. The steam is used in a turbine/generator to make electricity.

When the plant is shut down, the nuclear fuel in the reactor core continues to emit heat through the radioactive decay of fission byproducts. When the reactor is shut down, the rate of decay heat generation is initially about 7 percent of the thermal output of the reactor core at full power and then it decreases exponentially. The decay heat removal system is used to cool the water flowing through the reactor vessel in order to remove the decay heat being produced by the reactor core.

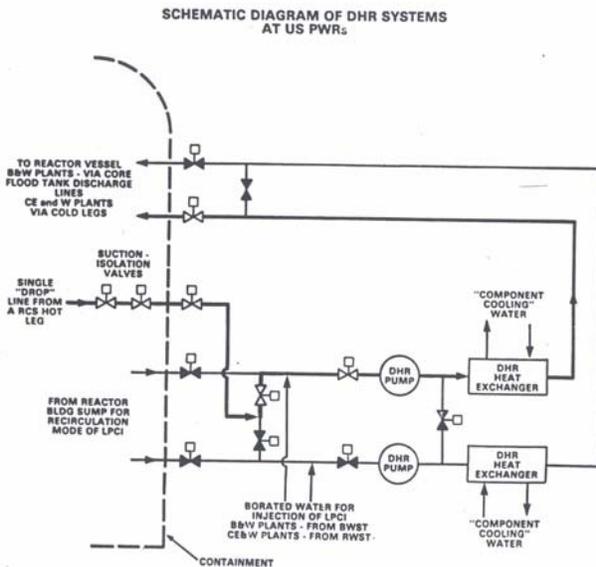
At the time of the discovery, the plant had been shut down about a week and the primary loop (i.e., the reactor vessel and the piping to and through the steam generator, the reactor coolant pump and back) had been partially drained until the water level was about two feet above the center of the hot leg piping (the pink-hued line in the diagram shown leaving the reactor vessel above and to the right of the reactor core).

At Davis-Besse and several other pressurized water reactors in the U.S., the decay heat removal system features a “single drop” configuration. In this design, a single pipe connects the decay heat removal system to the primary loop. Most of the decay heat removal system components (e.g., the decay heat removal pumps and heat exchangers) are located outside of the reactor containment structure, so this single pipe is routed through the containment’s concrete wall. Outside containment, the single line splits to provide water to each of the two sets of decay heat removal system cooling units. The water cooled by the decay heat removal system is returned to the containment and the core flood tank so it can re-enter the reactor vessel.
